DPF Regen Overview

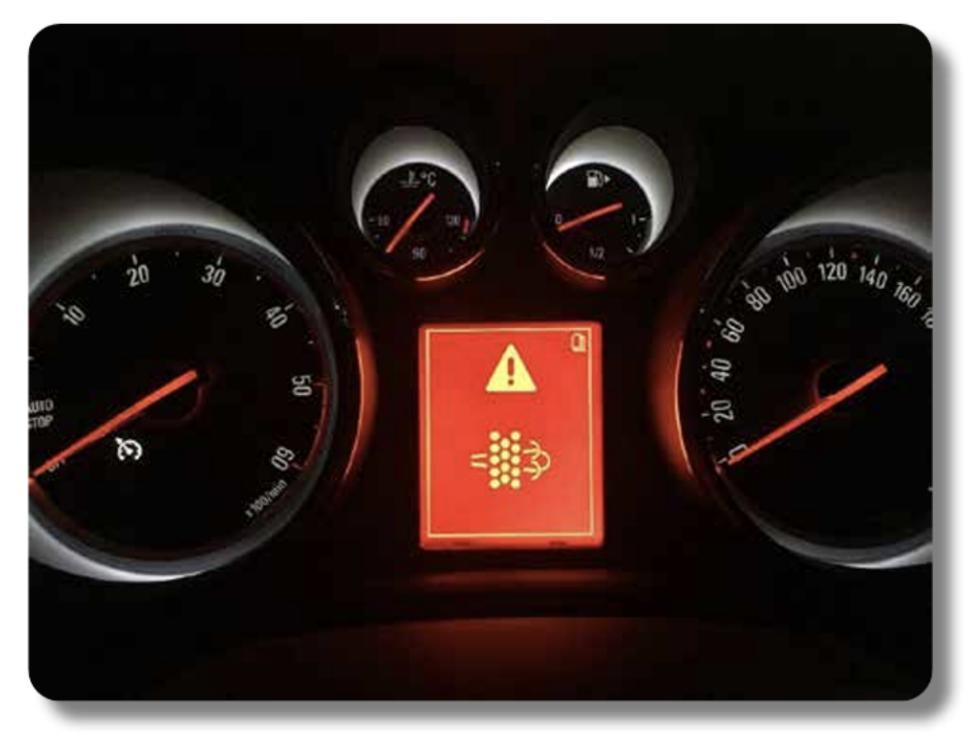
DPF warning lamp on. This lamp is normally off, except during startup to make sure it is working. The DPF lamp alerts the driver that passive regeneration is taking place. It also alerts the driver of the need for the driving mode to change, like increasing RPM or speed.

Malfunction Indicator Lamp (MIL) for HD-OBD CHECK ENGINE LAMP- Emission non-compliance indicator for EMO. Lamp ILLUMINATED when conditions are correct as set by the ECM diagnostic software
	DPF Lamp- -This lamp is normally off, except during startup to make sure it is working. DPF warning lamp to alert the driver that a regeneration needs to take place. It also alerts the driver that the need for the driving mode to change like increasing RPM or speed.
£-3,	HEST (high exhaust system temperature lamp) indicator lamp. The HEST lamp will illuminate when the exhaust system is too hot to safely contact and will most likely only illuminate under 5 MPH. The parameters of when this light will illuminate vary from manufacturer to manufacturer.
	DEF (diesel exhaust fluid) light may indicate a low DEF tank fluid level or it may illuminate if an SCR related fault is logged in the ECM (engine control module) or ACM (aftertreatment control module).

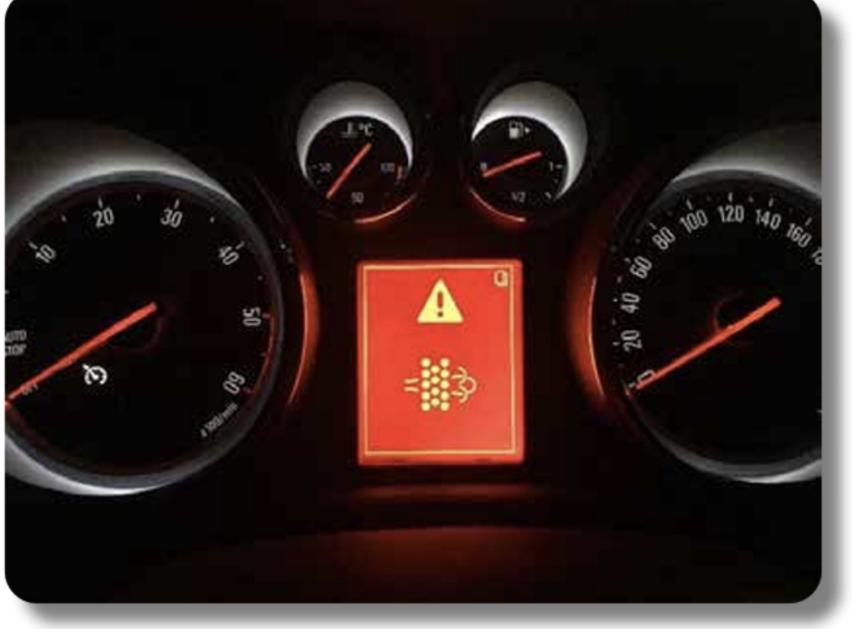
After the regeneration event begins, the engine speed will increase anywhere from 800 to 2500 RPM. If excessive exhaust temperatures are detected or if the exhaust temperatures failed to reach anticipated values within a specific time frame, the regeneration event will end. Any DTCs detected during the regeneration event, such as excess coolant temperature or a problem with the EGR system or intake air throttle, will also end the regeneration. Forced/service regenerations may take anywhere from 10, depending on the amount of soot loading. The temperature differential across the DPF measured by the EGT sensors will initially be quite high between the DPF inlet and outlet when the regeneration begins

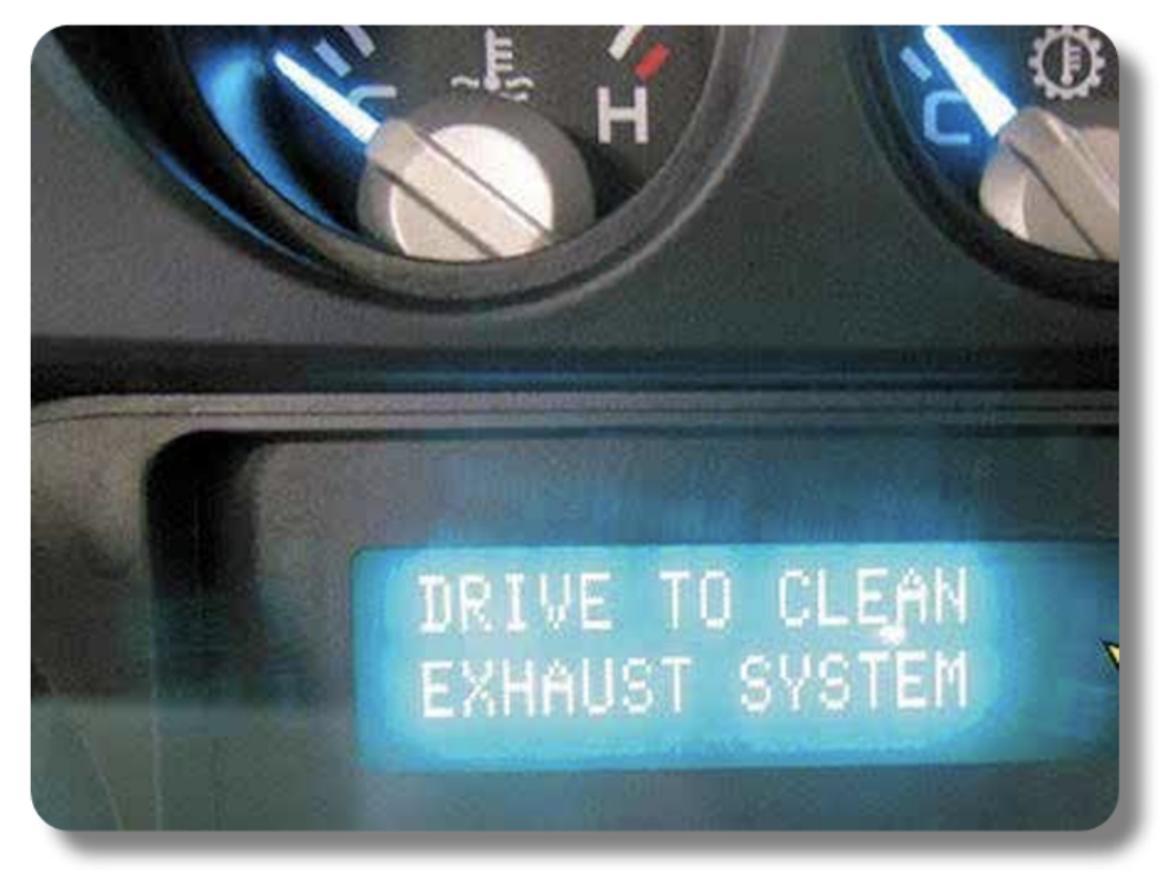
DPF operation indicator

The DPF (diesel particulate filter) lamp is normally off, except during startup to make sure it is working. The DPF warning lamp alerts the driver that passive regeneration is taking place. Prolonged low-load operation, which prevents the DPF from passively regenerating, also requires a warning to the driver to change driving style. The minimum vehicle speed of 30 mpg required for any passive regeneration may not be enough in some vehicles for regeneration after the DPF has been heavily soot loaded. A warning light or message in the driver's information center alerts the driver to increase engine speed and load as shown below. This is done by driving faster than 45 mph for 20-30 minutes to quickly regenerate the filter and lower the soot load. If the filter becomes excessively soot loaded, a power derate will progressively increase from 15% to 30% until the point when the engine shuts down.

The DPF warning light or message is normally off. If it is on, at typically around 80% of maximum safe soot load, it alerts the driver to change the engine's duty cycle, or driving mode, to increase the exhaust system's natural, load-dependent heating. This means you need a steady moderate speed rather than stop-and-go driving or short-trip operation. If a change in engine operation is not possible, an active regeneration is possible. The regeneration event can take place automatically or be initiated by the operator or by a technician using an electronic service tool. On a few late-model medium-duty vehicles, such as pickups and delivery vans, an operator can initiate a regeneration event. There can be a regeneration inhibit switch that is
